U. S. NAVAL PROVING GROUND
DAHLGREN, VIRGINIA

REPORT NO. 1095

RECOVERY FIRING OF 40MM PROJECTILE
COATED WITH MOLYBDENUM DISULFIDE

FINAL Report

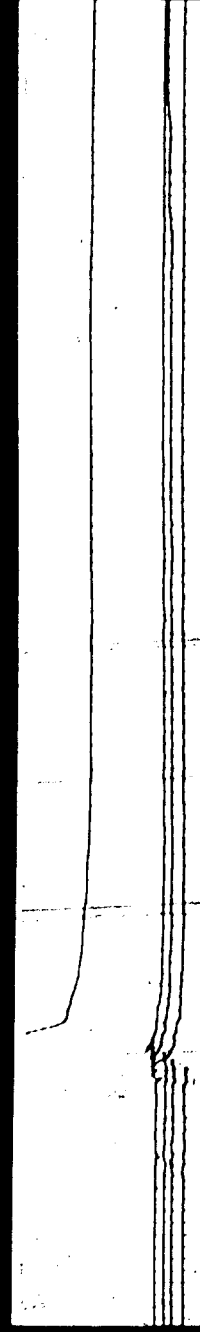
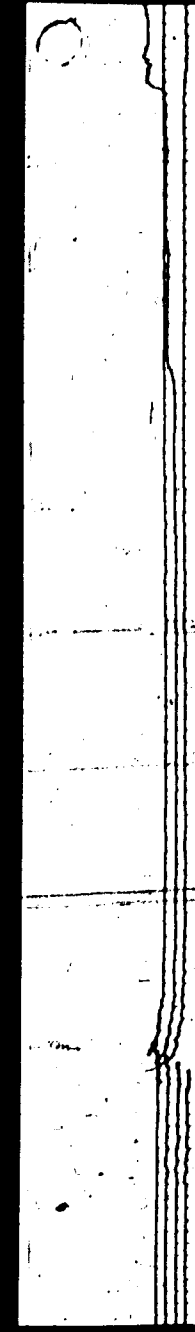
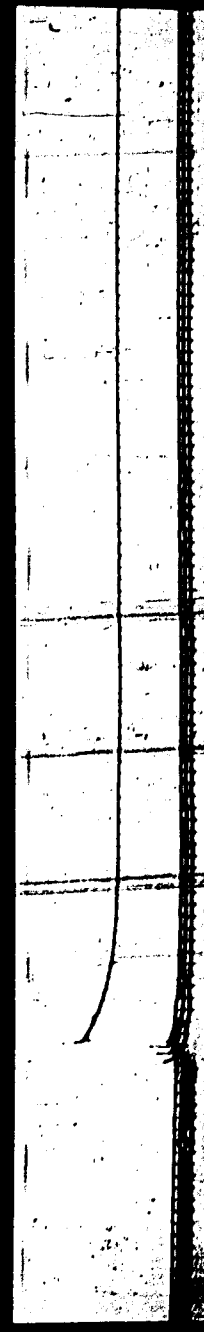
(Figure 22)

40MM Barrel No. M1-60449, Test of Molybdenum Disulfide
Strain Gage Measurements (Circumferentially)

Timing Marks are at One Millisecond Intervals

Rd.	Plateau - Peak	Plateau - Peak	Plateau - Peak	Remarks
1	220	375	260	445
3	230	575	255	465
4	225	520	255	445

Complete before and after firing data are given in Table I (Appendix (A)), and photographs of the recovered projectiles are included as Figures 1-20, inclusive. Strain gage measurements taken at four (4) points along the gun barrel are included as Table II. Photographs of the oscillograph records are included as Figures 22-27, inclusive.

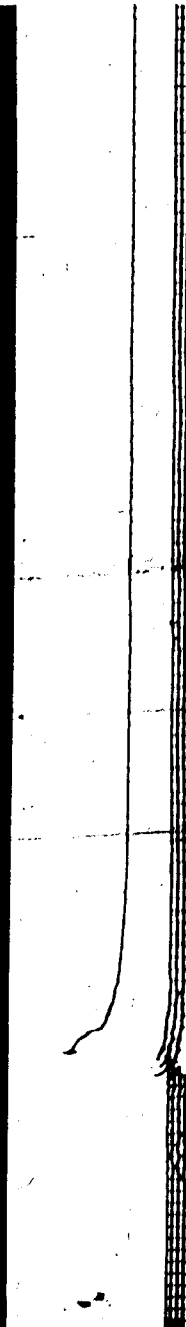
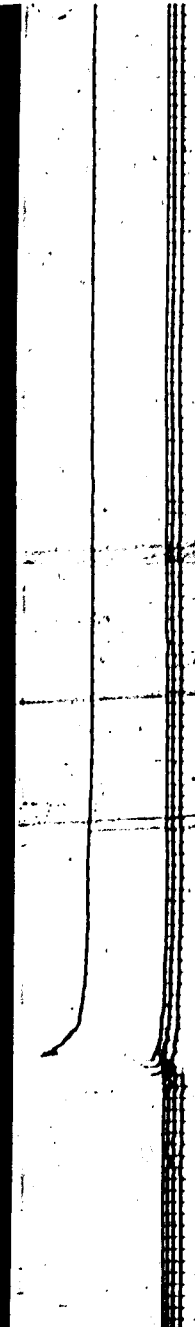
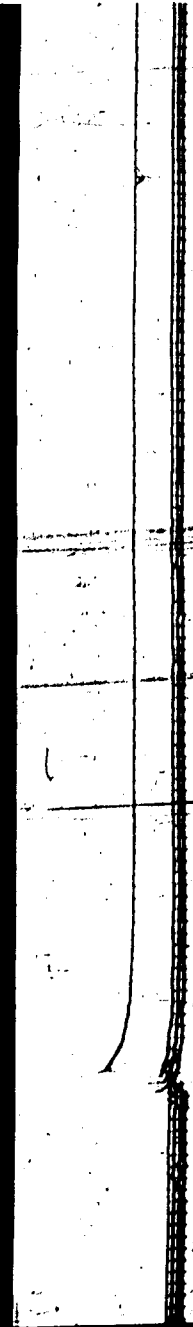
(Figure 23)

40MM Barrel No. M1-60449, Test of Molybdenum Disulfide

Timing Marks are at One Millisecond Intervals

Rd.	Strains in		Strains in		Strains in		R e m a r k s
	u ins./in. at 2400 from Muzzle	Plateau - Peak	u ins./in. at 20:25 from Muzzle	Plateau - Peak	u ins./in. at 38:50 from Muzzle	Plateau - Peak	
5	235	510	255	465	470	Band moly coated.	
6	255	575	240	415	475	" "	
7	235	590	255	400	475	" "

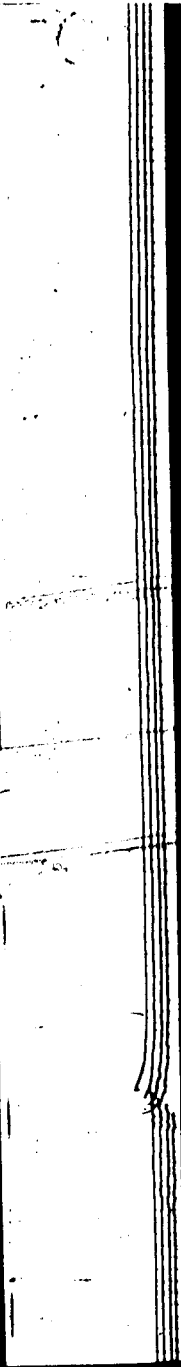
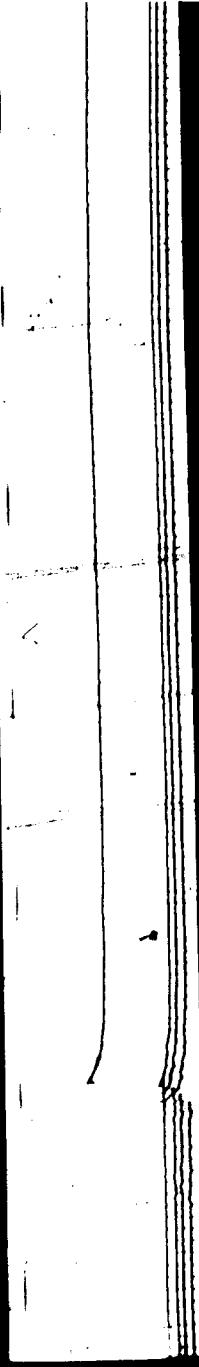
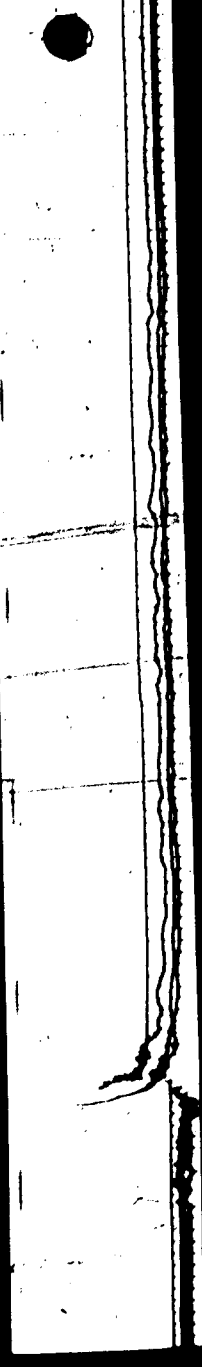
NP9-49061 (Continued) (Figure 25)

40MM Barrel No. M1-60449, Test of Molybdenum Disulfide
Strain Gage Measurements (Circumferentially)

Powder: SPLN 8541; Proj.: T1E1 Blunt Nose, Copper Bands (Over please)
Timing Marks are at One Millisecond Intervals

Strains in at 2400 from Muzzle	Strains in at 2025 from Muzzle	Strains in at 3850 from Muzzle	Strains in at 5075 from Muzzle	Remarks
1	445*	230	275	400	Warming round.
2		230	255	405	Bbl. moly. coated.
3		-	270	405	Normal cond.
4	325*	220	205	470	Normal cond.

* These values are doubtful because of a defective strain gage.
